Exmoor National Park
Historic Environment Report Series No 20

DULVERTON CONSERVATION AREA: APPRAISAL DOCUMENT

Consultation Draft: November 2014

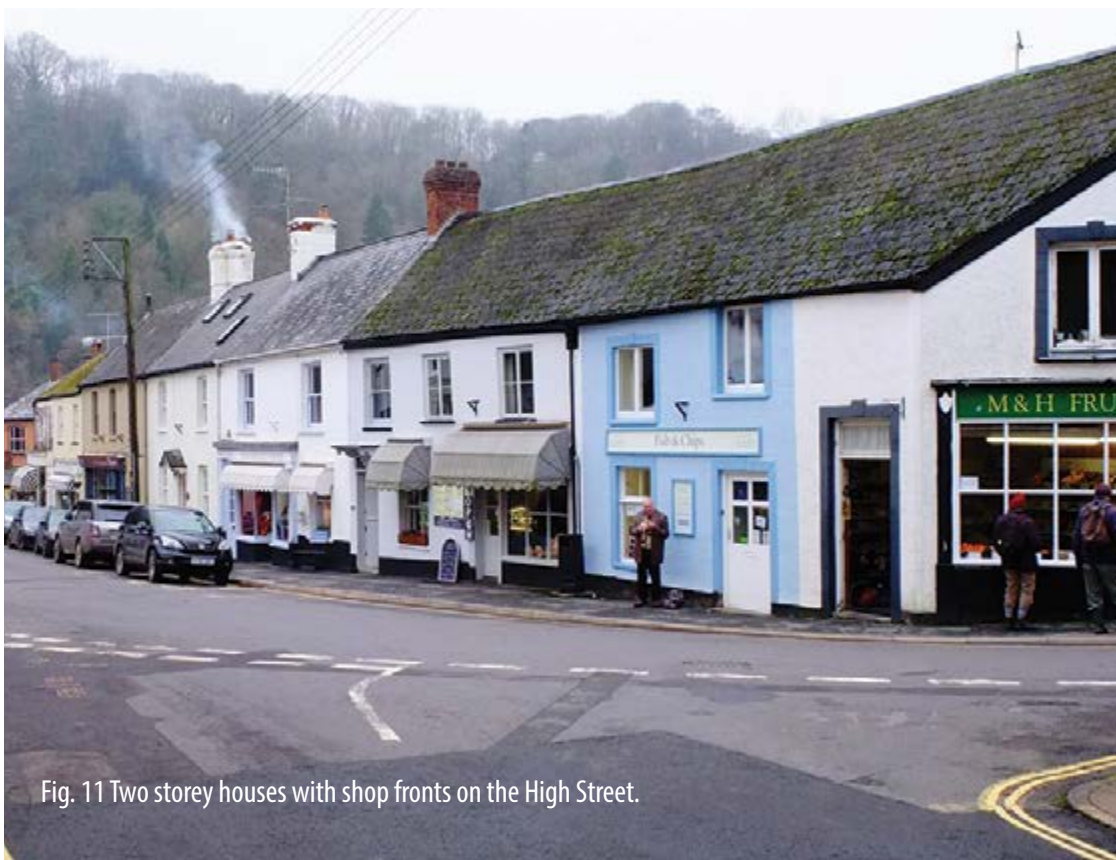
Fig. 11 Two storey houses with shop fronts on the High Street.

The town centre contains several large buildings, often prominently placed in the street scene, or where more concealed, within a well-defined setting. Other commercial or domestic buildings, forming the major part of the largely continuous main street frontages and are mostly 2 or 2 ½ storeys, many with shops on the ground floor. There are also several short terraces of cottages extending at right angles to the main frontages along narrow streets or courtyards.

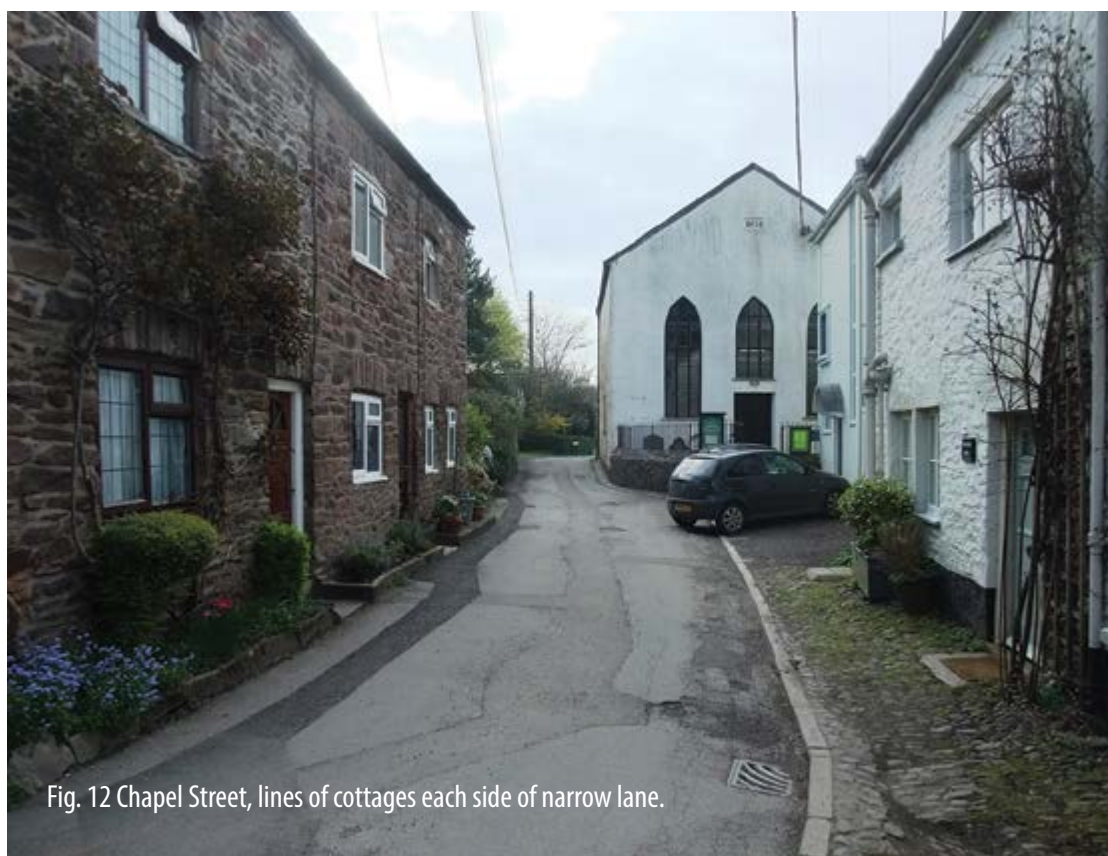
Fig. 12 Chapel Street, lines of cottages each side of narrow lane.

The buildings in this area are varied. It is broadly characterised by small cottages of 2-storey height, but also contains a larger and more imposing former mill buildings and Exmoor House (former Dulverton Workhouse).

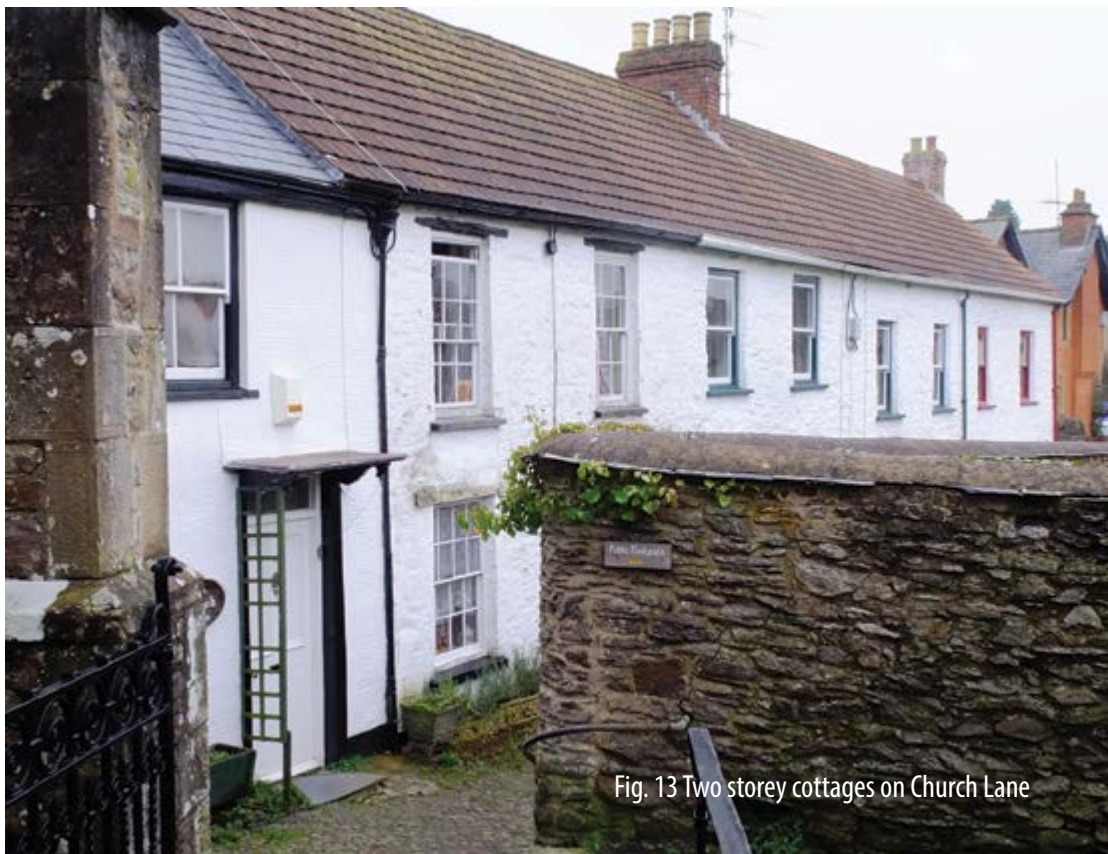
Fig. 13 Two storey cottages on Church Lane

The area around the church contains mainly 2-storey cottages. Woodlands and Woodliving represent higher status and earlier dwellings of rural rather than urban plan and include cross-passages.

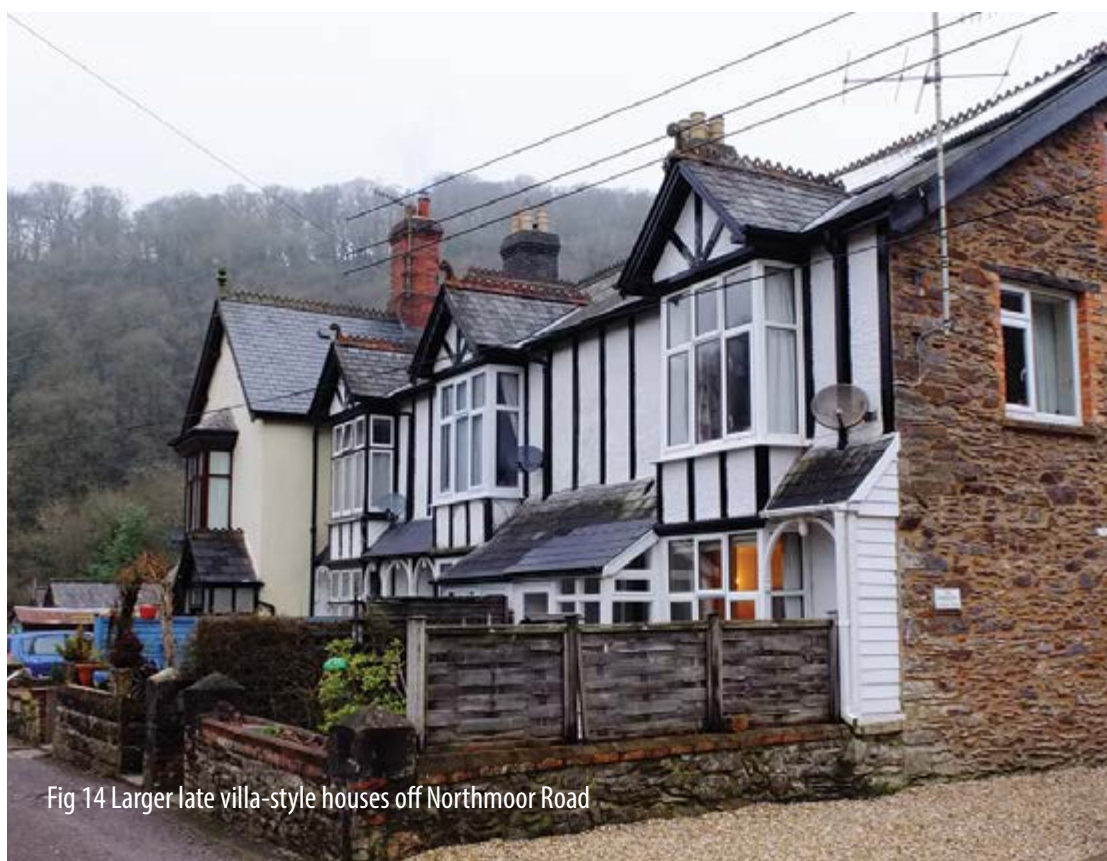
Fig 14 Larger late villa-style houses off Northmoor Road

The predominant building type is the small 2-storey terraced cottage, typical of the later 19th century, set along the valley floor. Slightly larger houses are found off the road, for example Addlemead and The Gardens which occupy level ground between the leat and river. The properties set higher up the valley sides on the opposite side of Northmoor Road are outside of the Conservation Area but have the potential to impact on its setting.

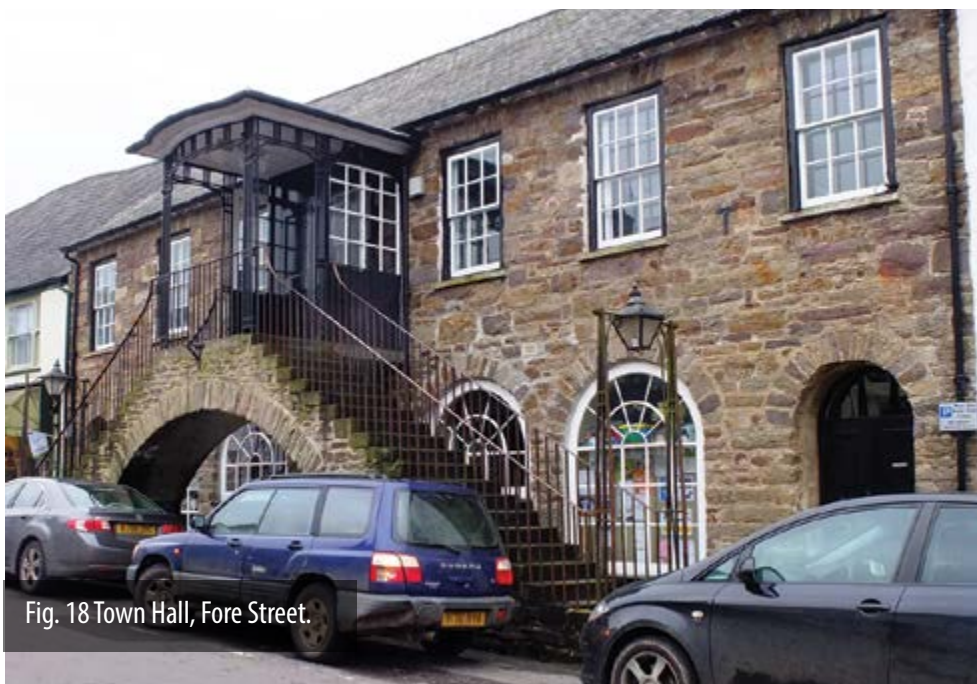
Fig. 18 Town Hall, Fore Street.

Standing at the centre of a small island between Fore Street and High Street is the **Town Hall** (Fig. 18), a former market house and now a public hall over shops. The original market house on this site dated to around 1760, the current building is from 1866 and has a seven-bay stone front. Its most notable feature, the arched staircase with twin arms leading to a central upper porch with veranda and ironwork has a lightness of touch reminiscent of Regency style but was actually added in 1930 by the architect Sir A.E. Richardson.

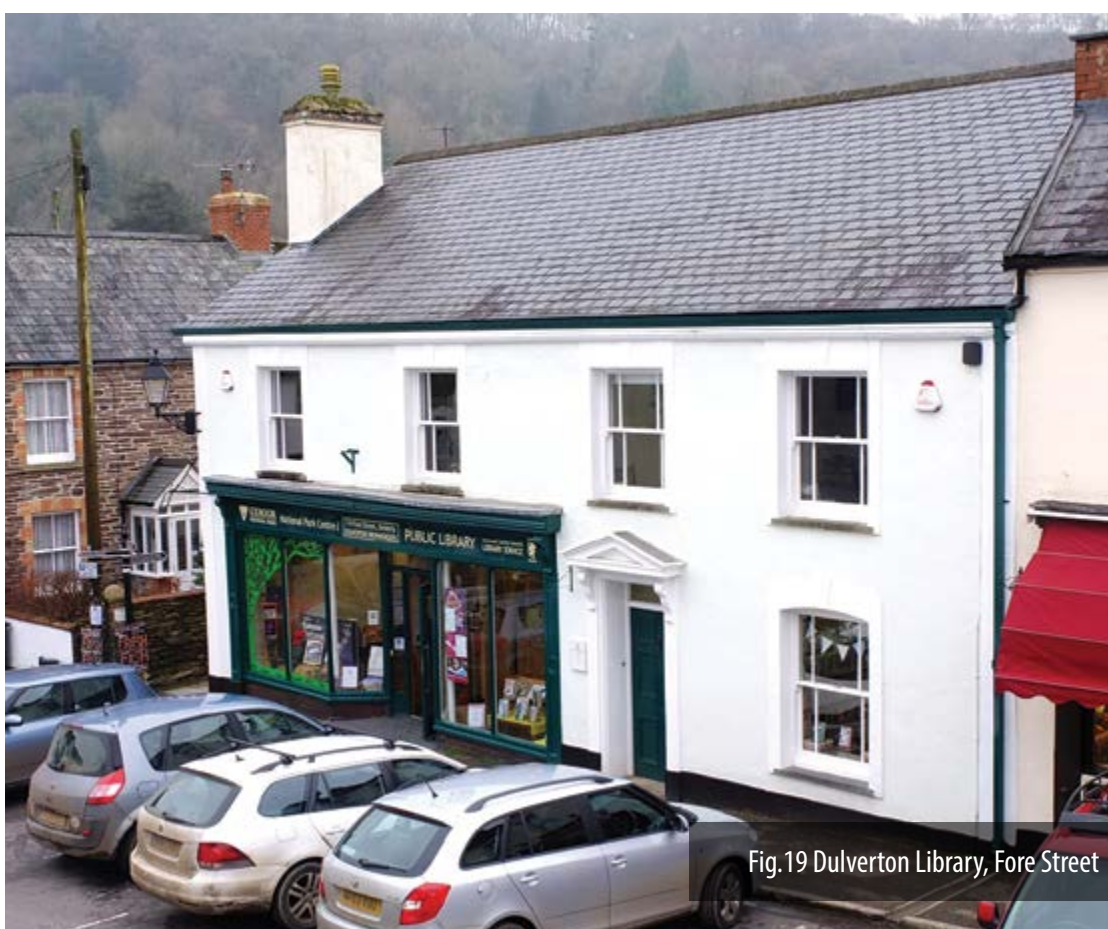
Fig.19 Dulverton Library, Fore Street

Opposite, the wide former shop frontage of the **Library** (Fig. 19) is probably early-mid 20th century, and is complemented by several other original late 19th –early 20th century shop-fronts, many with good period detailing. To the rear, the **Guildhall Centre** (Fig. 20) was originally the stables, malthouse and service buildings to the Lamb Inn before becoming part of Germans ironmongers. It was converted to its present use in the 1990s. Opposite and fronting a path are two three-cottage rows. **Monmouth Terrace** is built of stone rubble with polychromatic brick dressings and with original sash windows surviving and is late 19th century. The adjoining **Guildhall Terrace** is all brick and early 20th century in date. Between this row and the leat are contemporary brick-built early 20th century workshops/stables with top hinged casement windows and vertical plank doors with strap hinges.

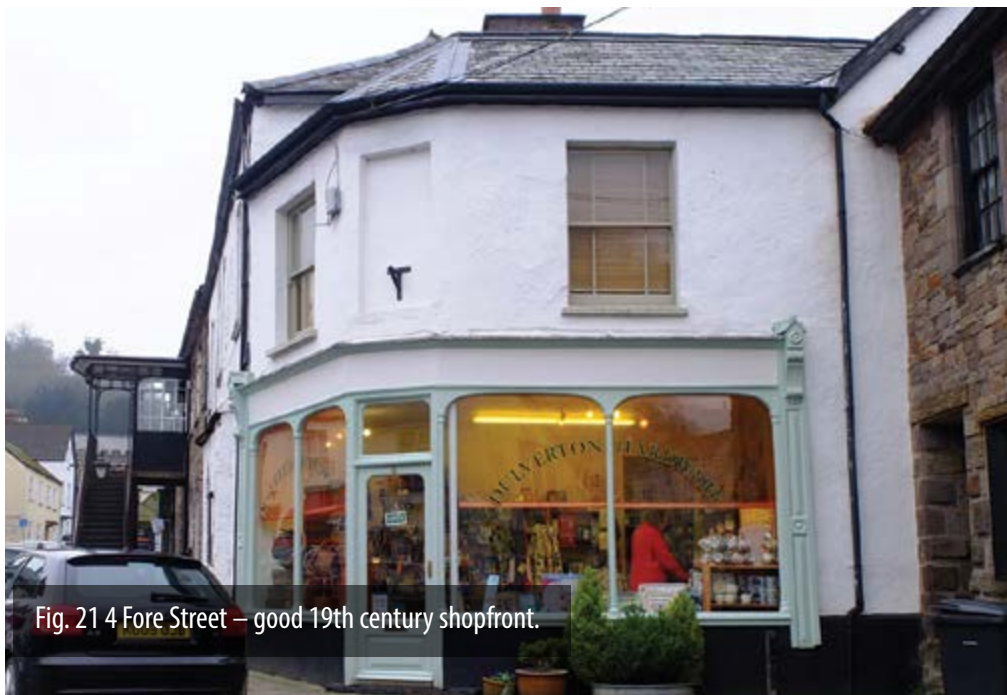
Fig. 21 4 Fore Street – good 19th century shopfront.

Back on Fore Street, **No.4 (Dulverton Hardware)** (Fig. 21) occupies a corner site and has a good late 19th or early 20th century shopfront with the entrance on the splay and ornate pilasters and consoles flanking the display windows and fascia.

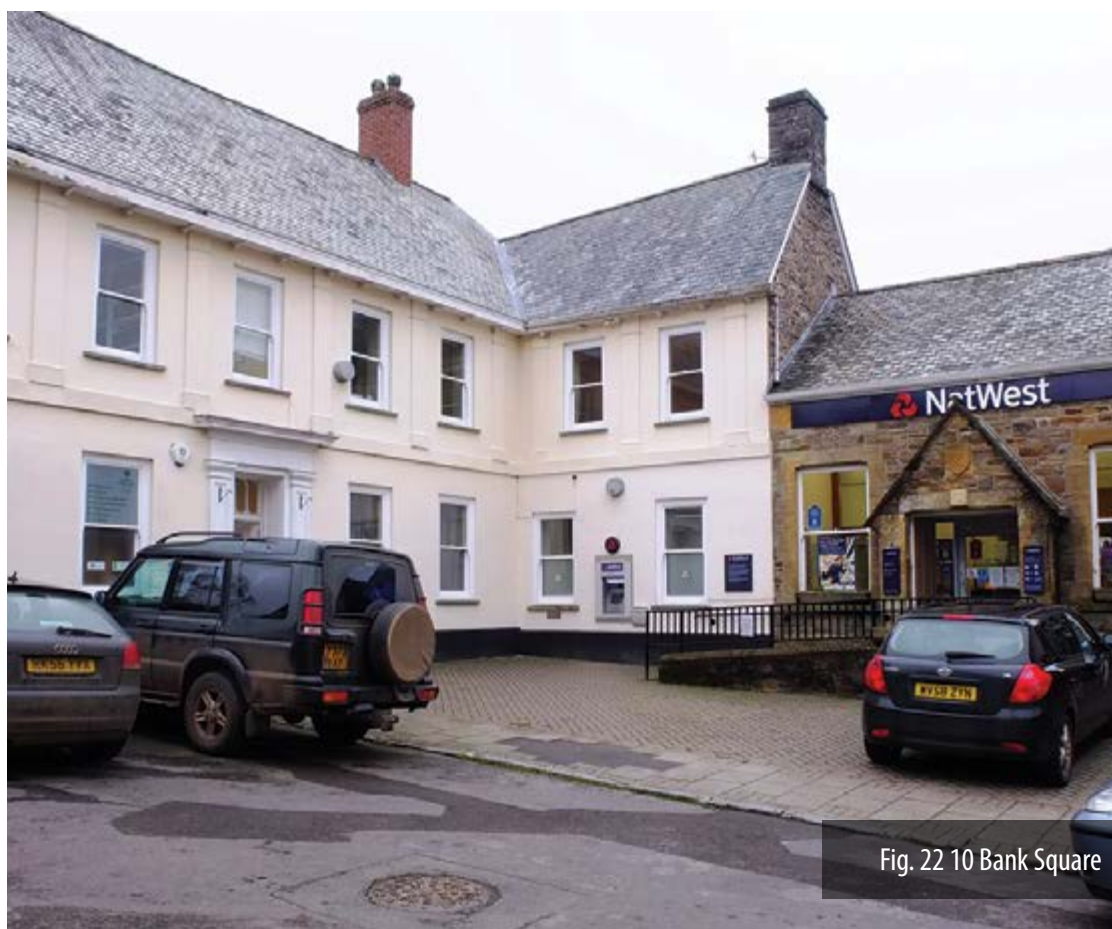
Fig. 22 10 Bank Square

North of the cross-roads, at the top of Bank Square and closing the view is **No 10** (Fig. 22) a 5-bay house. It probably dates from the early 19th century and is stuccoed with an imposing Classical entrance, including panelled door and four-light patterned glazing above. The plain sash windows are later in date, and the first floor has flat pilasters between bays rising from a plat band. It was formerly a bank in the 19th century until this function transferred to the building to its right.

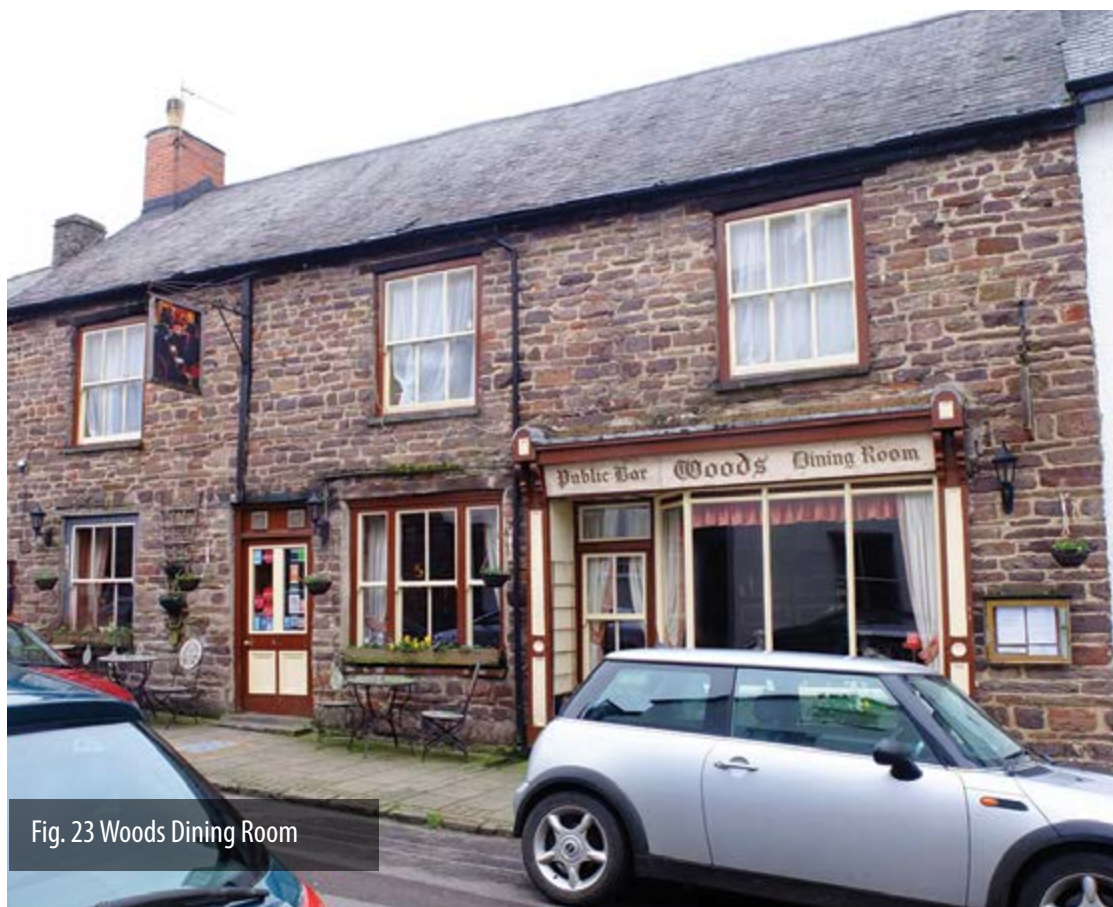
Fig. 23 Woods Dining Room

Opposite, **Woods Dining Room** (Fig. 23) incorporates a traditional shop-front with recessed entrance at the side, and has a frontage of roughly coursed local stone with sash windows including one tri-partite. The adjacent **Lion Hotel** (Fig. 24) is one of Dulverton's surviving historic hostelries. Occupying a corner site, it has a tripartite plan with the central section having a half-timbered pediment flanked by cambered-head dormers each side. All windows to the front elevation are six-over-six sashes and the flat-roofed central porch is surmounted by two brightly painted recumbent lion figures.

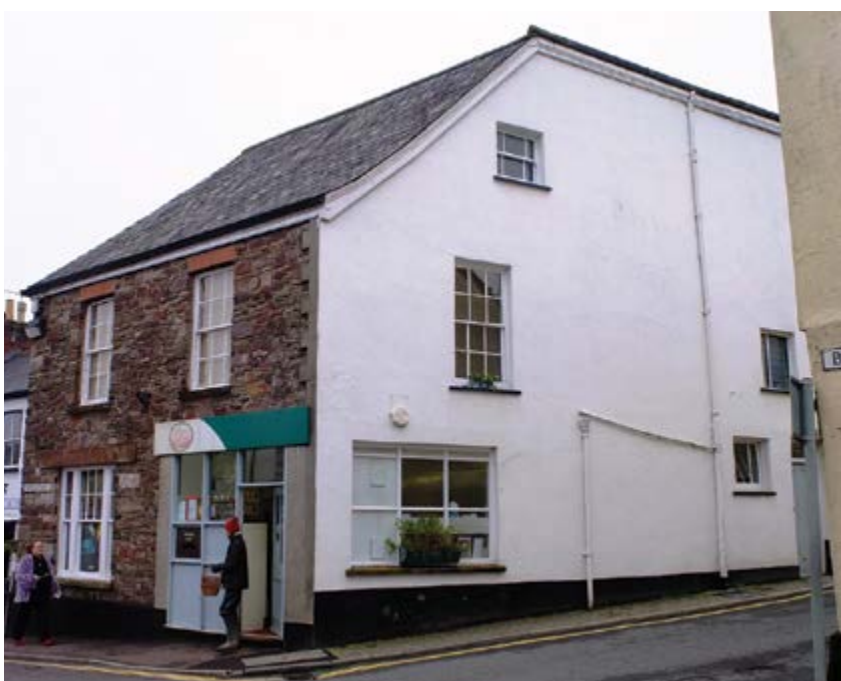
Fig. 25 Dulverton Post Office, corner of High Steet and Lady Street

On the north side of Fore Street, the façade of **Dulverton Post Office** (Fig. 25) projects forward but is on the same alignment as Bank Square, which combined with the angled corner suggests it was truncated by Lady Street being widened. Although it has a 19th century appearance, Richard Parker's internal inspection has shown that parts date to the 17th century.

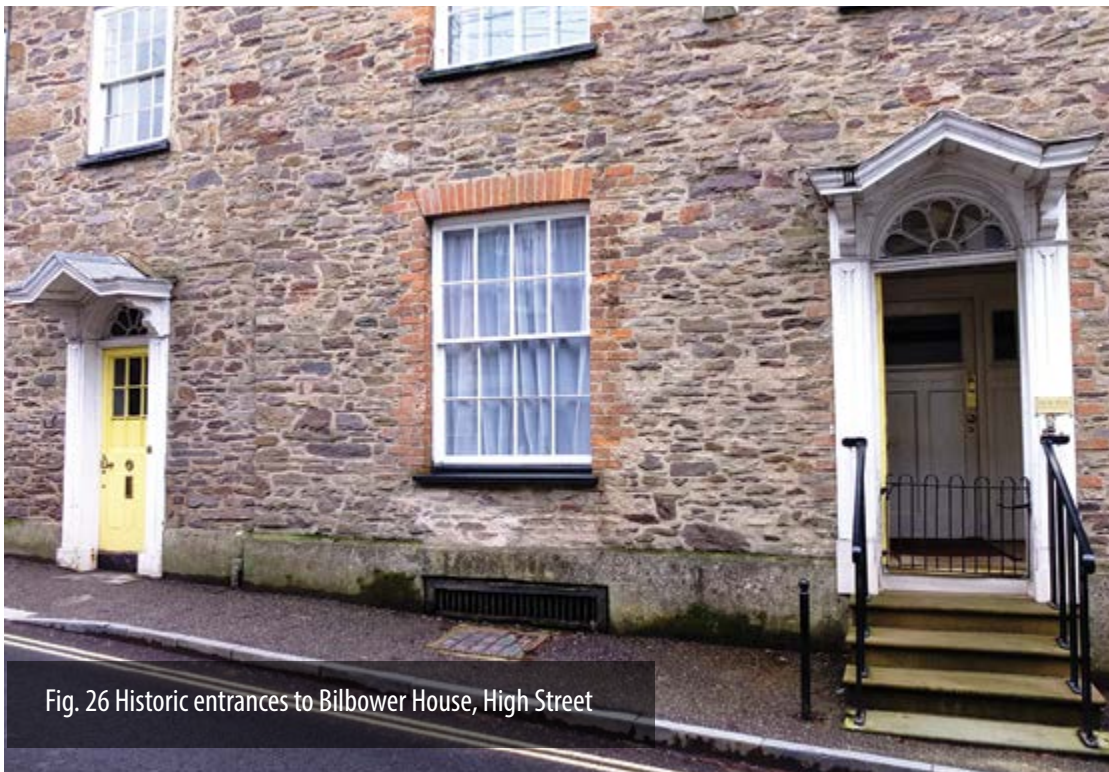
Fig. 26 Historic entrances to Bilbower House, High Street

The upper part of the High Street, from Union Street to Vicarage Hill, contains a number of notable buildings. On the south side, **Bilbower House (Nos 50-52)** (Fig. 26) is two houses and part of a row and of late-18th/ early-19th century date. Built of local stone rubble with slate roofs, one half was rebuilt in the late 19th century with brick surrounds to window openings. Both have good quality fluted pilaster doorcases with fanlights (Fig. 77) and half-glazed and panelled doors respectively, the lower house is fronted by a short flight of stone steps with a wrought iron handrail.

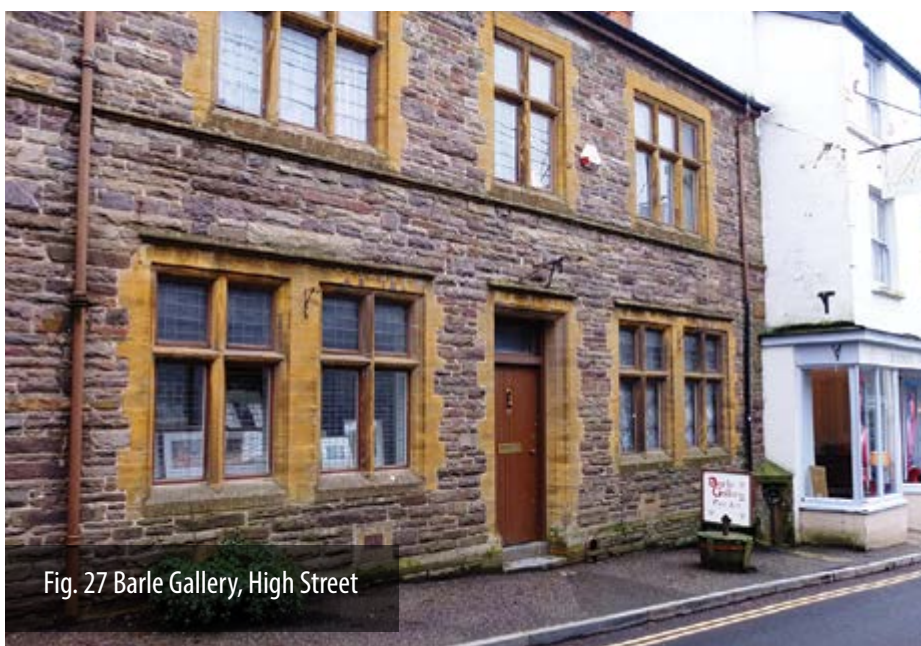
Fig. 27 Barle Gallery, High Street

Next door, the **Barle Gallery** (No. 48) (Fig. 27) has a rebuilt early 20th century frontage of snecked local stone with Ham Hill stone mullions and part-leaded windows. Almost opposite, **Sydenham House** (Fig. 28) is one of the most historically interesting buildings in the town and is likely to be late mediaeval in date with later phases of alteration. It comprises a long low rubblestone range running parallel to the street and dominated by a large lateral stack. The upper part is boarded, suggesting that the eaves level has been raised.

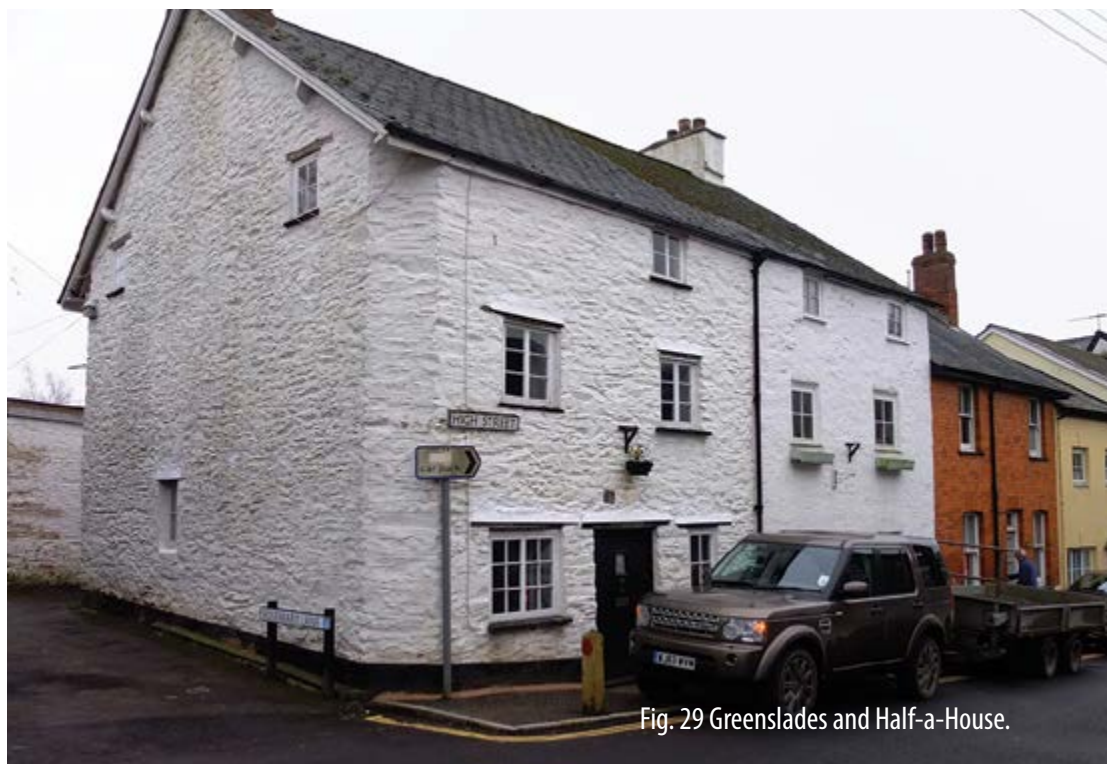
Fig. 29 Greenslades and Half-a-House.

Further up the hill at the junction with Rosemary Lane is **Greenslades** (Fig.29) and an adjoining cottage, probably 18th century or earlier. The irregular three-storey frontage of painted stone rubble has small three-light casement windows with timber lintels. Off Rosemary Lane, **Chypleighs** (Fig. 30) is an early 19th century cottage, roughcast over rubble and possibly adapted from an earlier two-cell and cross-passage plan dwelling with stone stacks at either end. There are pointed gothic arch openings; the windows are casements with divided tracery heads, and the door of vertical plank construction.

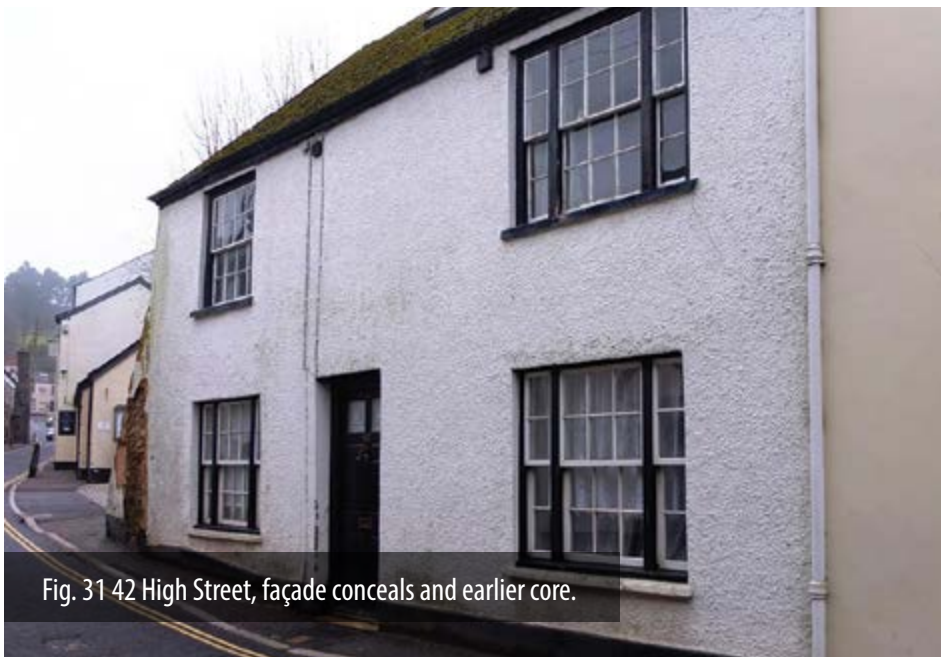
The middle part of the High Street also contains a number of historic buildings that make a positive contribution to the Conservation Area. **No 42** (Fig. 31) on the west side of the entrance to the car park appears typical. Externally, its modest façade suggests a late 18th or early 19th century date but to the rear and internally the layout and timbers suggest an important building perhaps 200 years earlier.

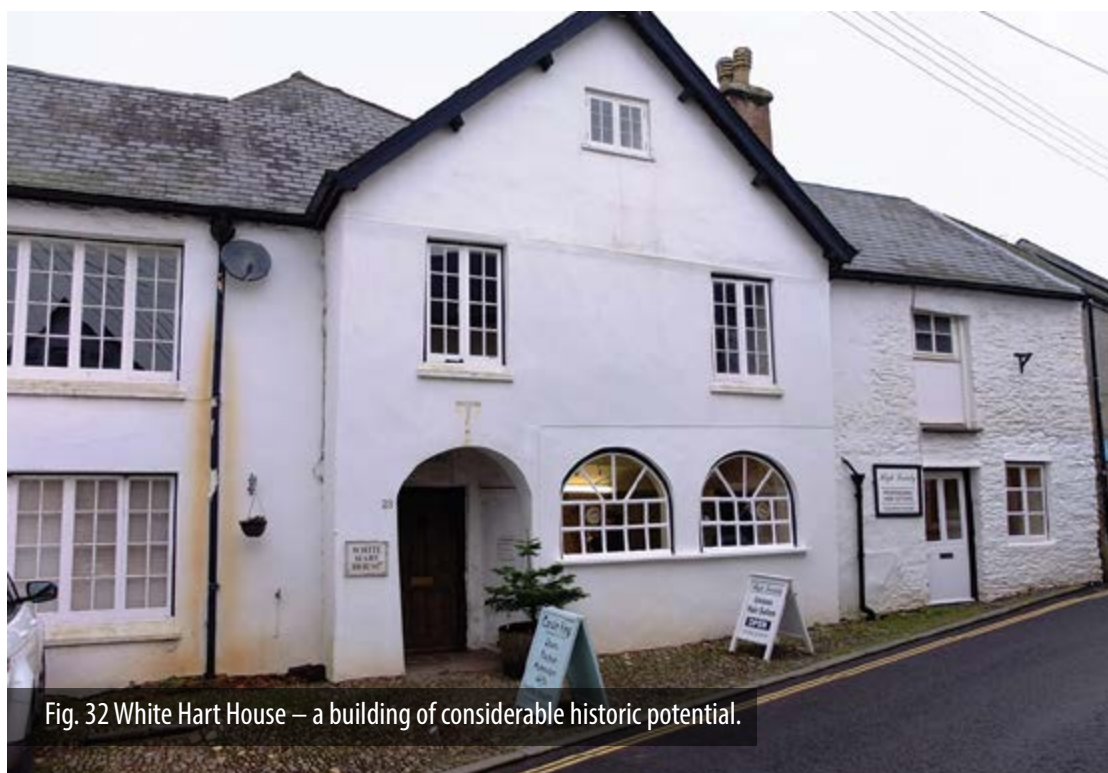
Another building of interest, **White Hart House (No. 23)** (Fig. 32) is located on the island between Fore Street and High Street and forms a 'C-shaped' range around a small front cobbled courtyard. Its two storey frontage to the High Street has a large gable containing an attic storey. The ground floor has a deep semicircular arched entrance porch and adjoining round-headed windows with radial glazing bars. An internal inspection by Richard Parker has revealed the building to date to the 15th or 16th century and raises the intriguing possibility that it may have originated as a market house or guildhall.

Fig. 32 White Hart House – a building of considerable historic potential.

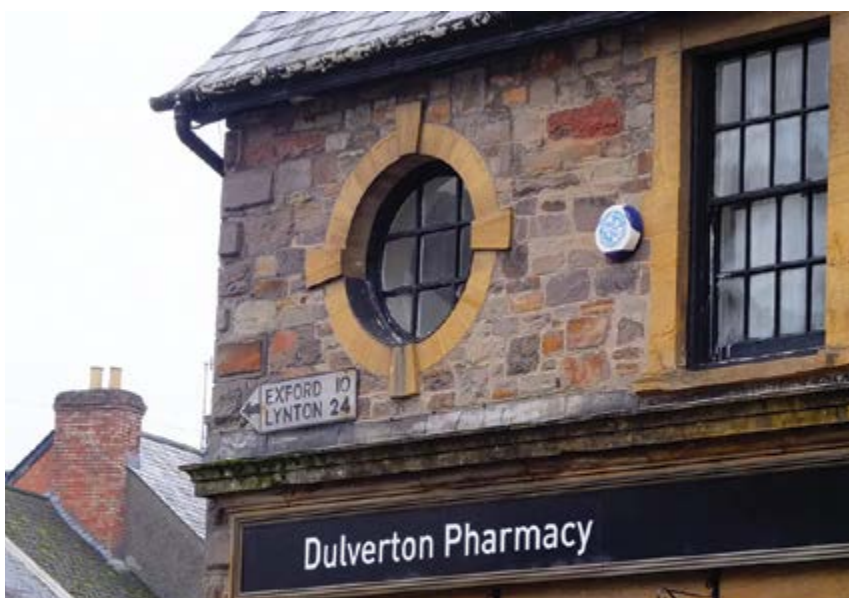
Fig. 33 First floor roundel window to Dulverton Pharmacy.

Closing the view back towards the middle of the High Street is **Dulverton Pharmacy (No.21)** (Fig. 33). This appears to be a re-fronting of an earlier building in an early 20th century Arts & Crafts style with leaded-light windows and an impressive frontage of dressed Ham Hill stone, including a first floor roundel window with opposed keystones.

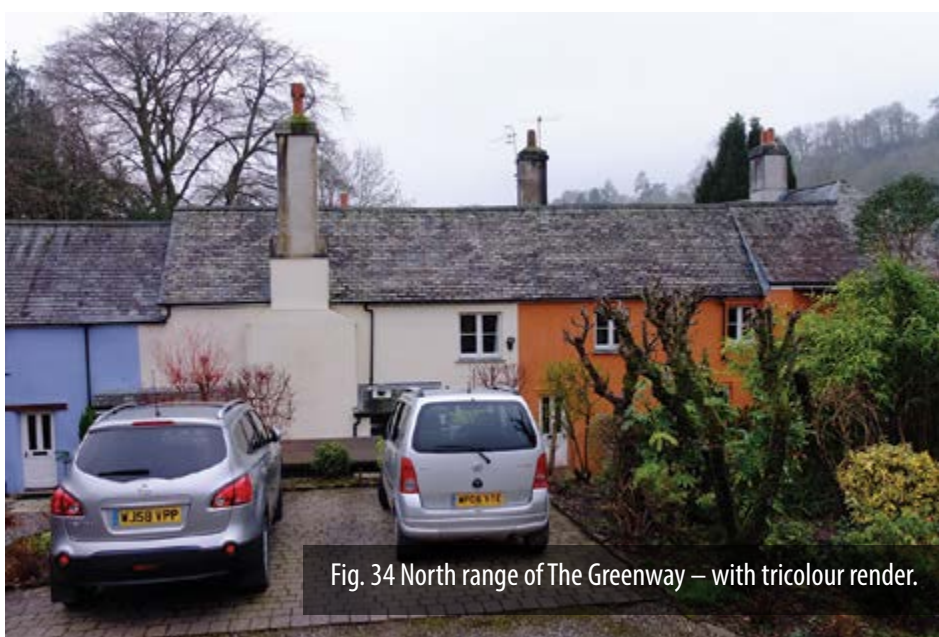
On the opposite side of the High Street and down a narrow lane is **The Greenway** (Fig. 34), a late 18th –early 19th century fronting of an earlier house. It is rendered over rubble and has a hipped slate roof. Its main south-facing two-storey 5 bay range is in Regency style with ground floor 15- pane sashes reaching to ground level and similar first floor windows of 12-panes. There is a central semicircular headed entrance with panelled reveals and above the door a fanlight with radiating bars. The interior is said to retain significant period detail, for example, panelled shutters to windows, a stick baluster stair, and segmental-headed doorway also containing a fanlight.

Fig. 34 North range of The Greenway – with tricolour render.

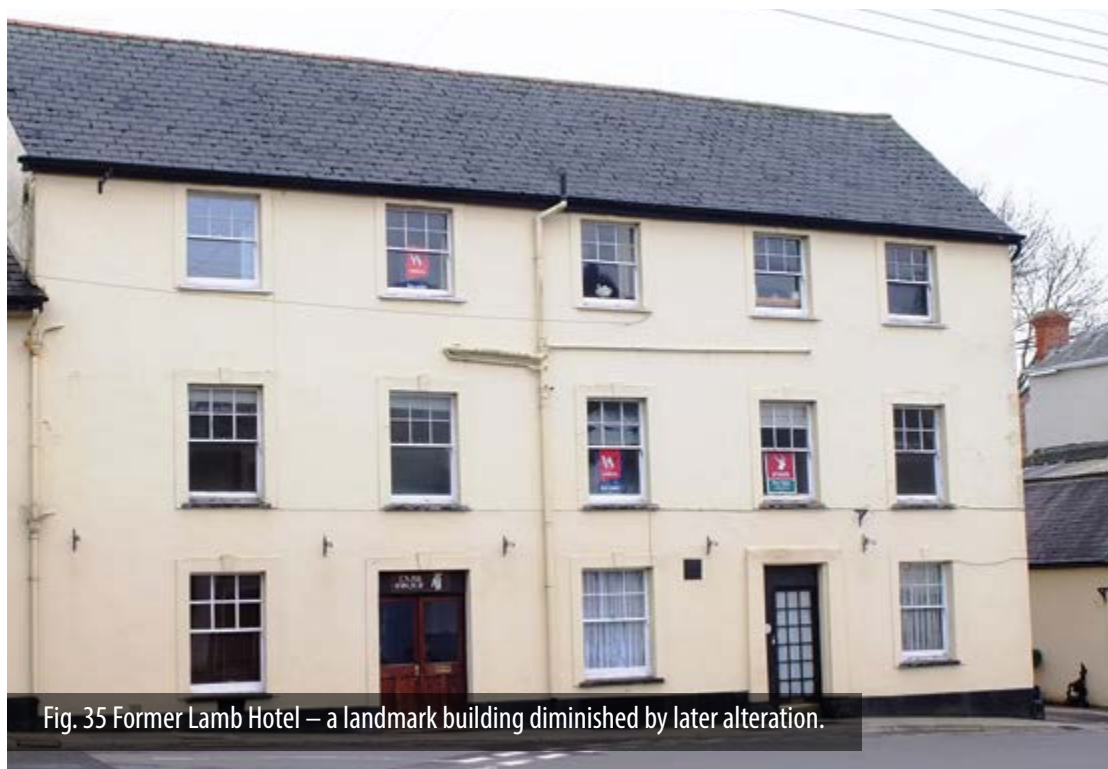
Back on the High Street and a prominent town centre building, the **Lamb Hotel (now Lamb Court)** (Fig. 35) is an imposing 3-storey 5-bay building probably dating to the late 18th century. The former hotel and outbuildings to the rear were converted into flats in late 1980s resulting in the loss of much of its character, including the 4 large chimney stacks and the impressive ionic porch that was admired by the architectural historian Pevsner.

Fig. 35 Former Lamb Hotel – a landmark building diminished by later alteration.

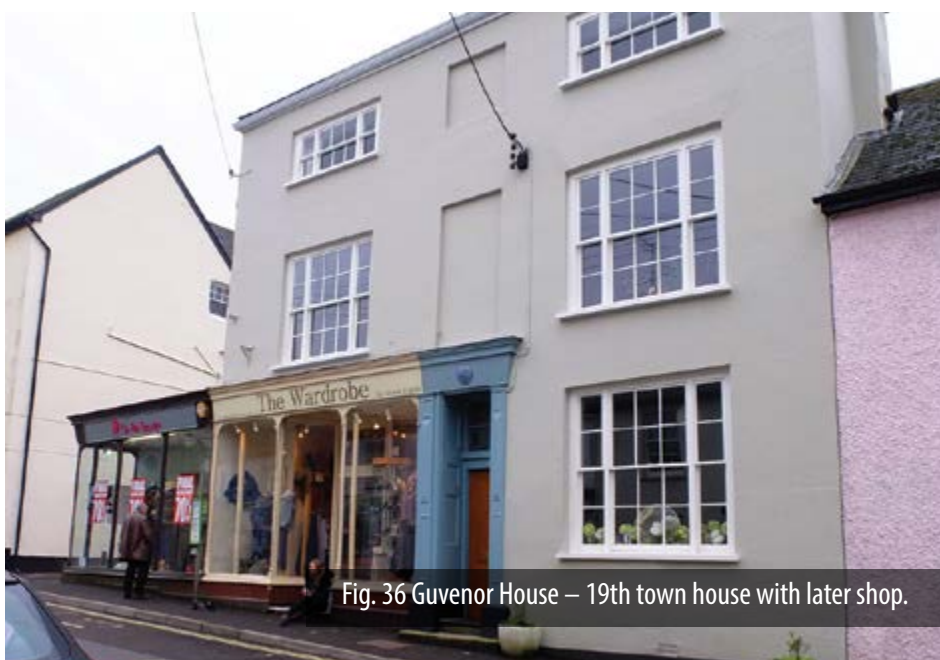
The adjacent **Guvenor House (No. 18)** (Fig. 36) is also a large three-storey building, in its current guise it is a substantial town house of c.1800 with a later shop window inserted in its three-bay symmetrical façade with a blind centre bay and tri-partite sash windows to the first floor. An internal inspection, however, suggests it may be a remodelling of a 17th century building. The shopfront is also of interest and has panelled reveals and lozenge pattern in flanking pilasters.

Fig. 36 Guvenor House – 19th town house with later shop.

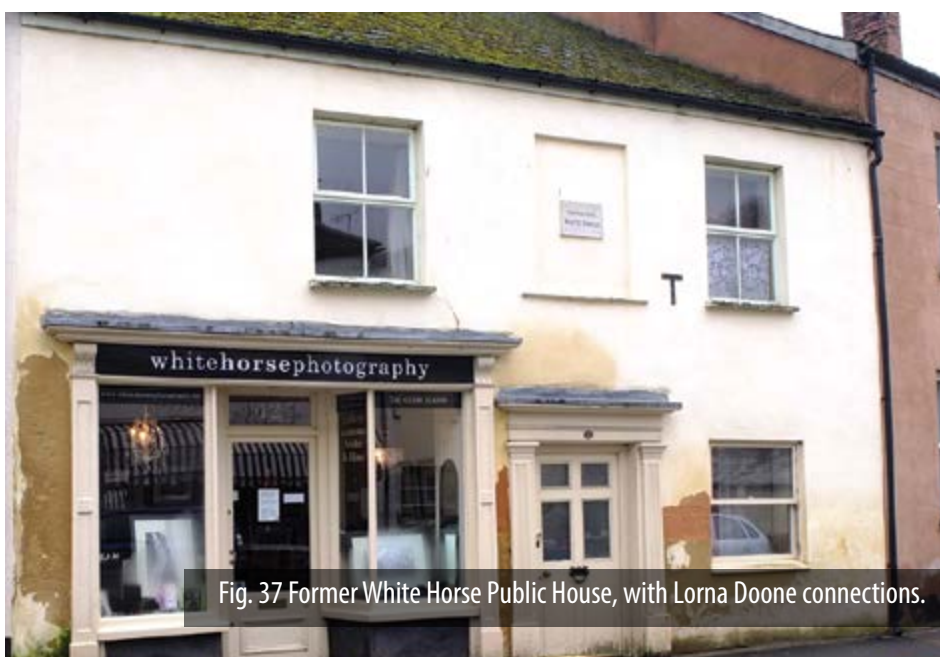
The remainder of the buildings on the High Street as it heads west towards the Barle are two storey. **No. 12** (Fig. 37) is described on a wall plaque as 'The historic White Horse' and is probably of 18th century origin or earlier, but with a mid-late 19th century frontage including a shop-front with central recessed entrance door and cornice supported by curved console brackets flanking the fascia. Adjoining is a six-panel door (the upper four glazed) within a heavy door-case with fluted pediments and flat hood with cornice above.

Fig. 37 Former White Horse Public House, with Lorna Doone connections.

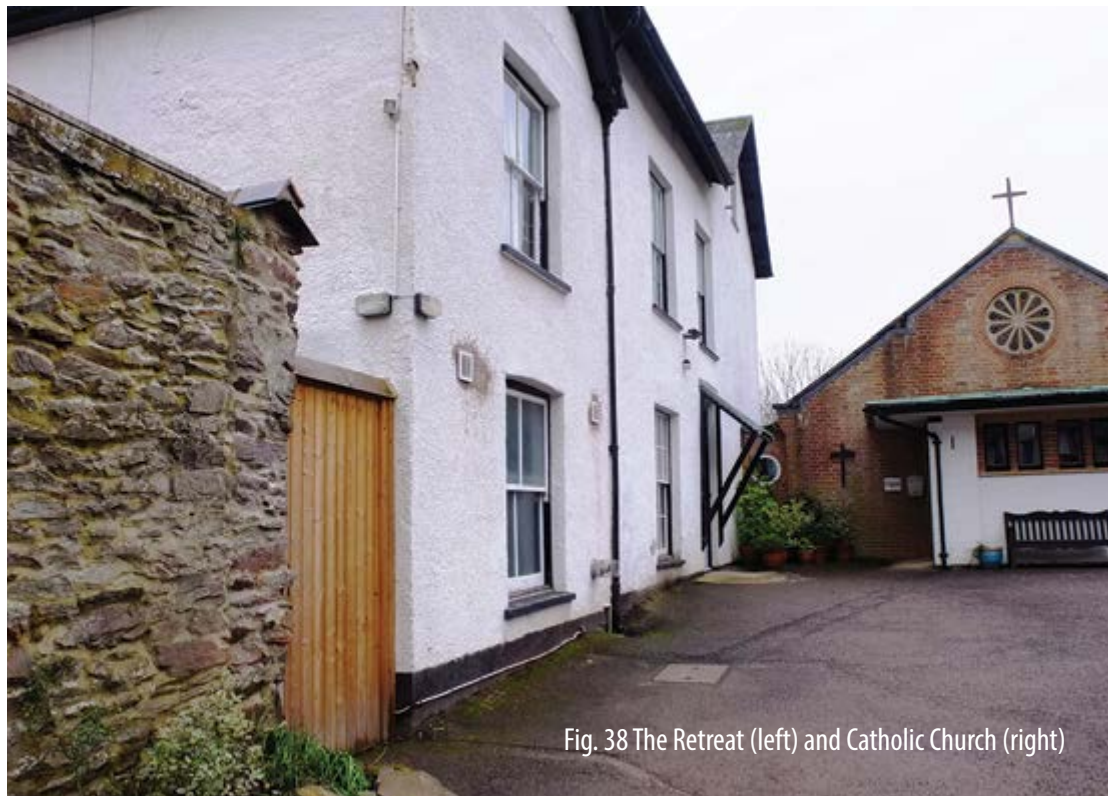
Fig. 38 The Retreat (left) and Catholic Church (right)

The **Catholic Church** was formerly the stables to the adjacent the large 19th century house known as **The Retreat** and were converted to a church in 1955 (Fig. 38). Both are set back off the main street frontage.

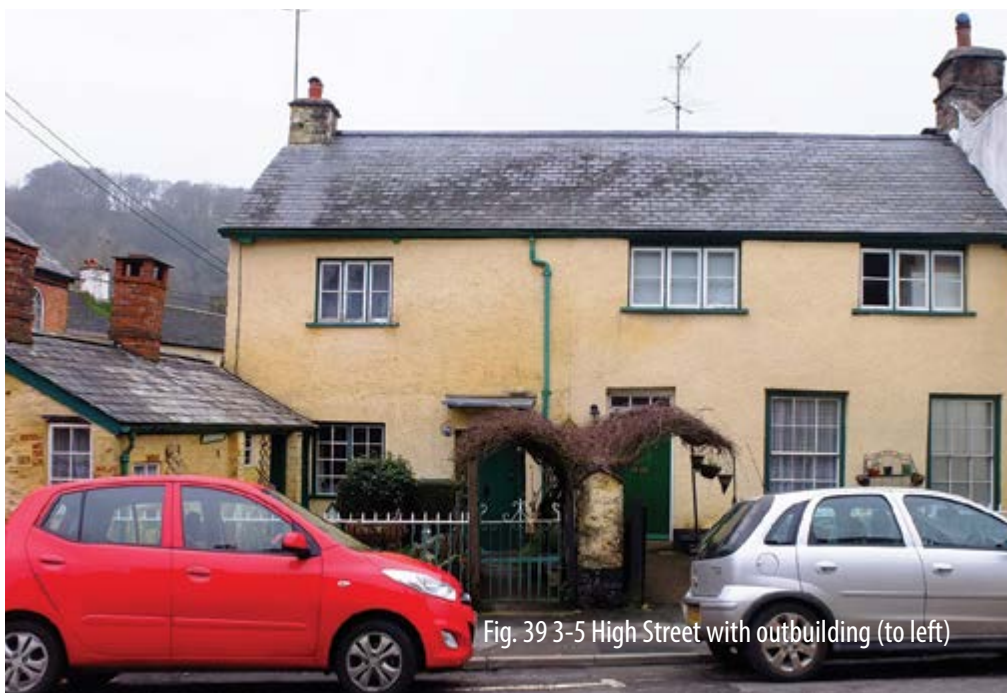
Fig. 39 3-5 High Street with outbuilding (to left)

On the north side of the street and set back slightly, **3 and 5 High Street** (Fig. 39) were formerly a single house, probably 17th century or earlier and three rooms with cross-passage. The listing details suggest an original hall to which a rear lateral stack was added, probably in the 17th century. The original house was remodelled, extended and divided in the early-mid 19th century with two surviving 12-pane sash windows and later 19th - early 20th century casements with horizontal glazing bars. No. 3 has a single storey outbuilding projecting forward with a mono-pitched roof and twin stacks.

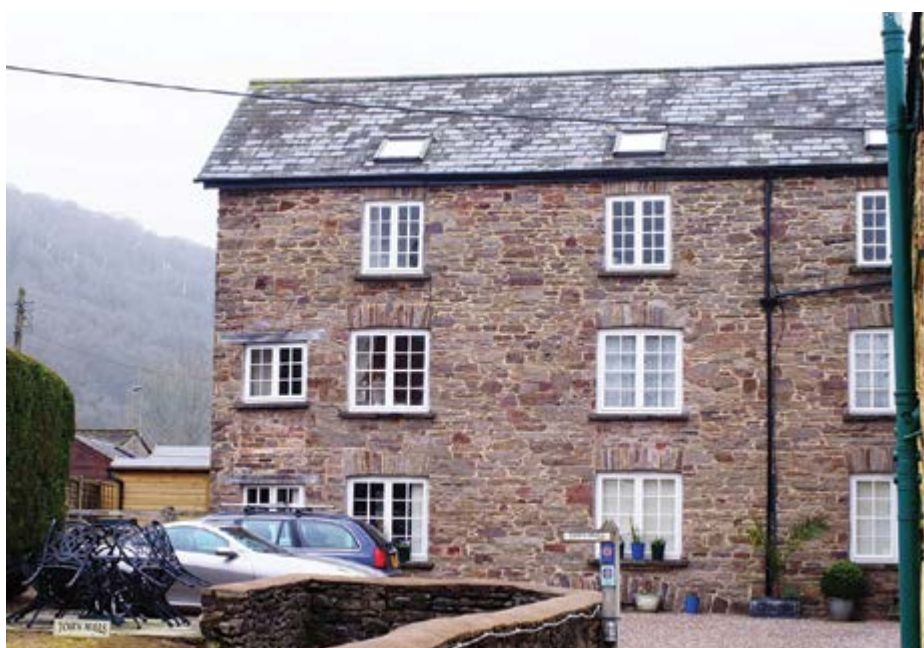
Fig. 40 Town Mills

To the rear, **Town Mills** (Fig. 40) is one of the 19th century grist mills, almost certainly with earlier origins. It is of three-storeys, with a transverse wing across the leat. Predominantly built of local sandstone rubble there is some timber panel infill and segmental arched openings with six-light casement windows.

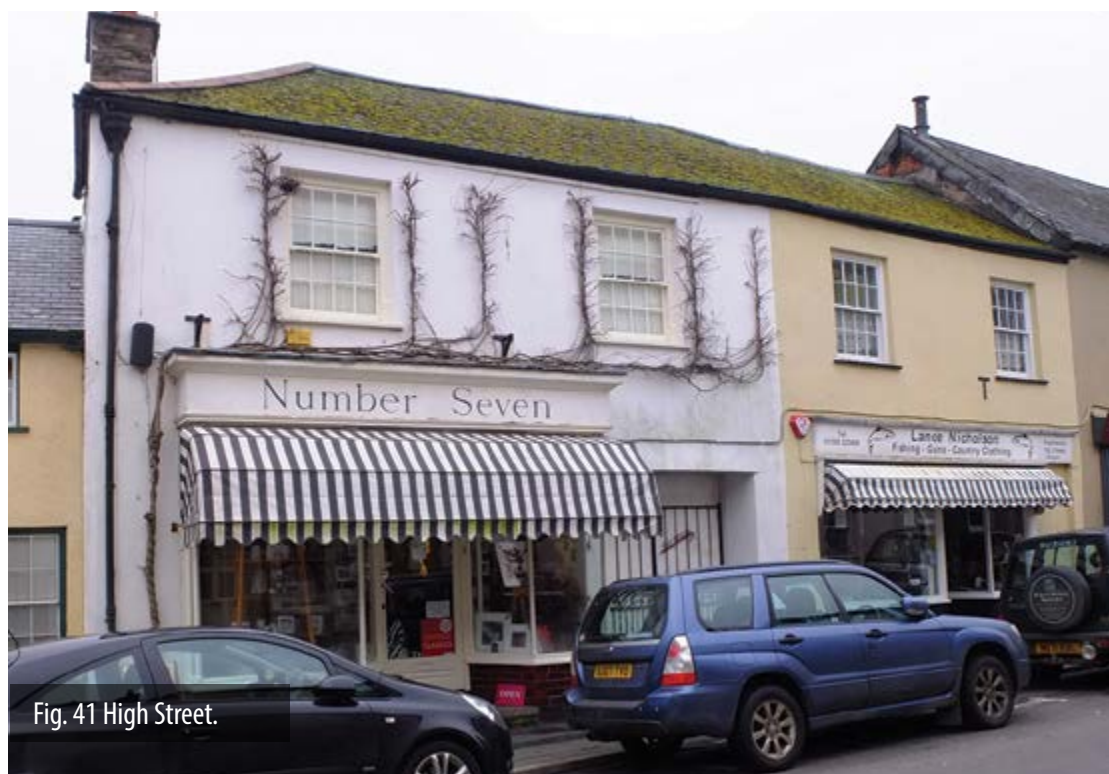
The remainder of the lower end of **High Street**, has a well-proportioned sequence of late 18th and 19th century two-storey frontages with a number of traditional shop-fronts, and first floor sash windows with narrow glazing bars, especially its south facing elevation. **Nos 7 and 9** (Fig. 41) are fairly typical and represent a 19th century rebuilding of an 18th century building.

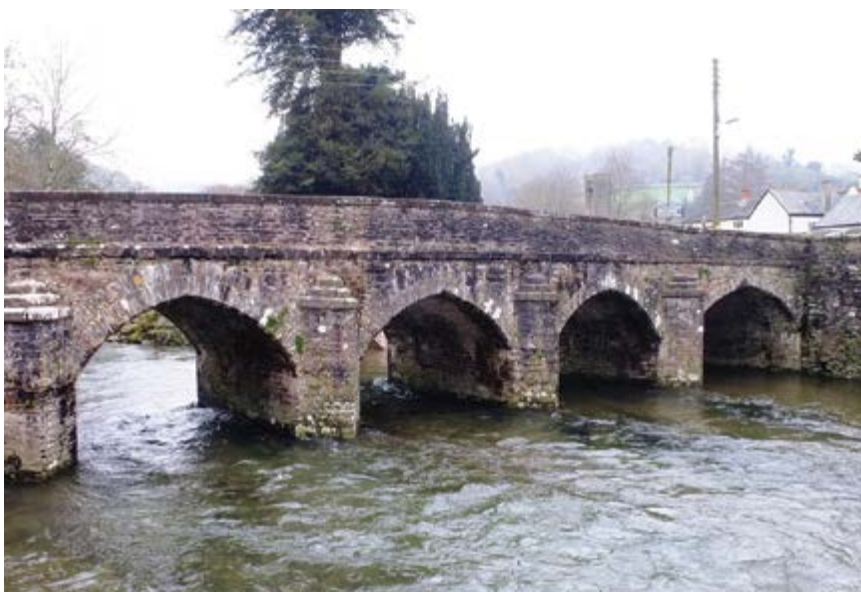
Fig. 42 The Barle Bridge

The Barle Bridge marks the western entry to the town. It is built of local stone rubble with ashlar string course and coping and spans the river in five arches with pointed cutwater buttresses between a four-centre central arch. It is medieval in origin, but was repaired in 1624, and widened in 1819 by John Stone. It has had to be repaired after flood damage on many occasions, notably in 1866, 1952 and 2012.
